# Research on the Propagation of AE Signals in Helicopter Structural Components

**Abstract** – The paper contains results of experimental research carried out helicopter bench. In order to create an attenuation chart for AE signal amplitude in helicopter fuselage, a number of experiments were performed on the frame and stringers, inside the fuselage. Later helicopter test bench was used to develop defect localization methodology of helicopter structure fatigue damage technical diagnostics. Analysing helicopter structural defects for different helicopters types it is concluded that the joint elements of helicopter tail boom are still exposed to fatigue crack formation. AE method shows highly effective results predicting fracture of helicopter joint elements.

#### IV. ANALYSIS OF TEST RESULTS PRIOR TO THE FAILURE OF BOLT NO. 15

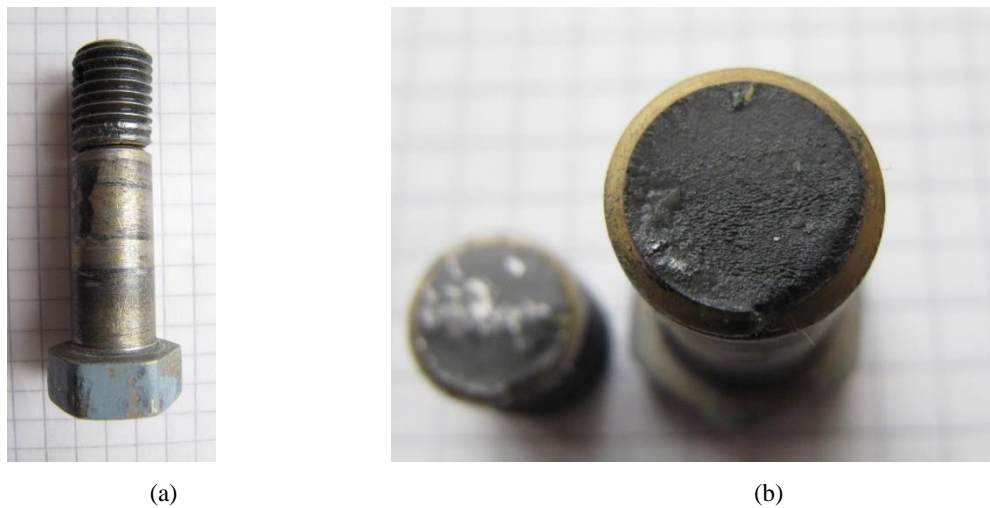
In the process of inspection in 78 603 cycles, some loosening of attachment bolt No. 15 in the area of stringer No. 1 along the right side was found. The failure was detected on the basis of AE monitoring data [6] in 78 600 load cycles. To remove the bolt, the helicopter tail boom weight was relieved. The bolt appeared to be destroyed and came out without any effort.

The fracture (Fig. 7 b) has a fatigue nature [1], [4], [9]. The nucleus area of the crack is in the base of the first (from the cylindrical part of the bolt) thread turn profile at a distance of 28 mm from the head (Fig. 7 a). By the direction of lettering on the bolt head and marking on the end of its threaded part it was stated that the nucleus area of the crack is on the outer side of the bolt relative to the tail boom axis (Fig. 6).

Fig. 6. Bolt No. 15. (a) Overall view. (b) Fatigue fracture.

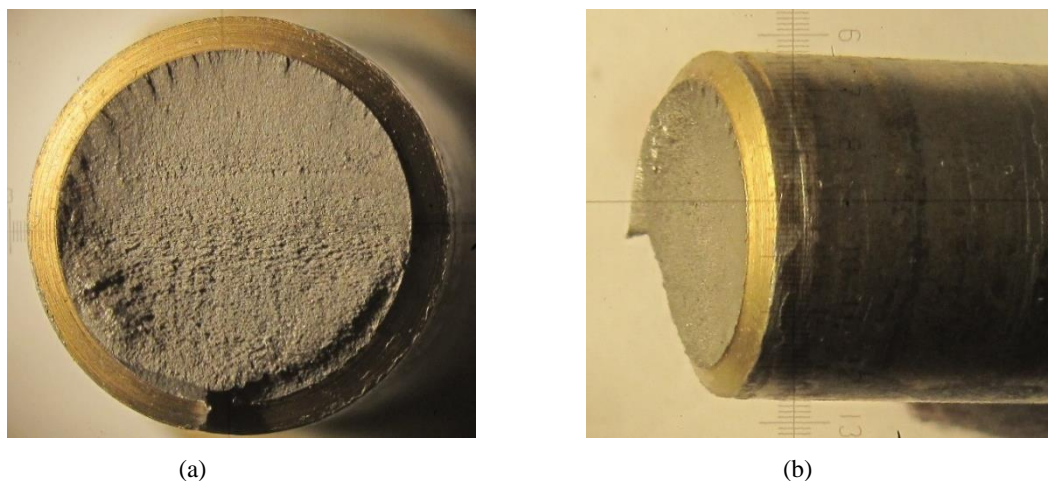
The fracture fatigue zone occupies about 95 % of the area and consists of a fine-grained site and a coarse-grained site (Fig. 7).

On a radius of 3.5 mm from the nucleus area of the crack (bolt diameter in fracture – 10 mm) a fatigue relief zone can be seen (Fig. 7).

Fig. 7. (a) General and (b) side views of the bolt fatigue fracture, bolt No. 15.

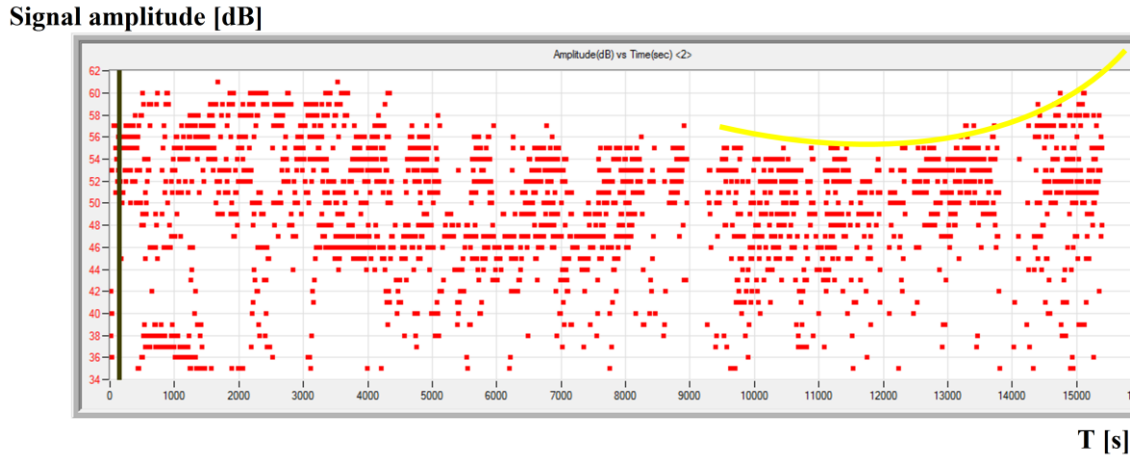
The moment of failure of bolt No. 15 was registered by all the AE sensors installed in the area of tail boom and fuselage joint. The failure was detected in 78 800 load cycles. The accelerated growth of the crack in the material of bolt No. 15 was detected by the growth of AE signal amplitude from

55 dB to 62 dB (Fig. 8) in a range of 76 500 to 76 700 load cycles, i.e. in 2100 to 2300 cycles up to a complete failure, which corresponds to 42–44 flying hours.

Fig. 8. Time-dependent behaviour of AE signal amplitude, dB (y axis) during the accelerated growth of the crack, s (x axis), bolt No. 15.

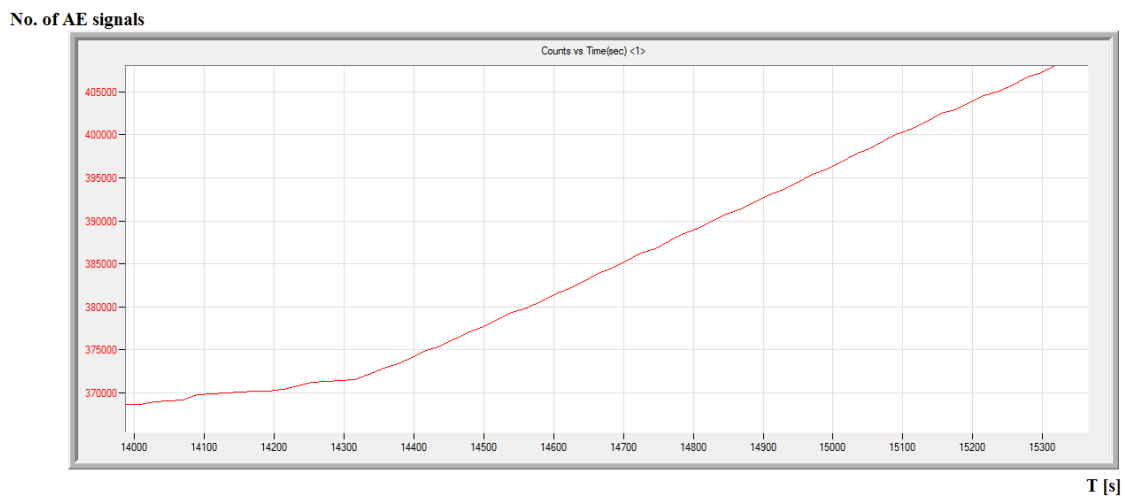
The behaviour of total AE signals (Fig. 9) is also an evidence of the beginning of accelerated crack growth in the material of bolt No. 15.

Fig. 9. Time-dependent behaviour of total AE signals (y axis) during the accelerated growth of the crack, s (x axis), bolt No. 15.

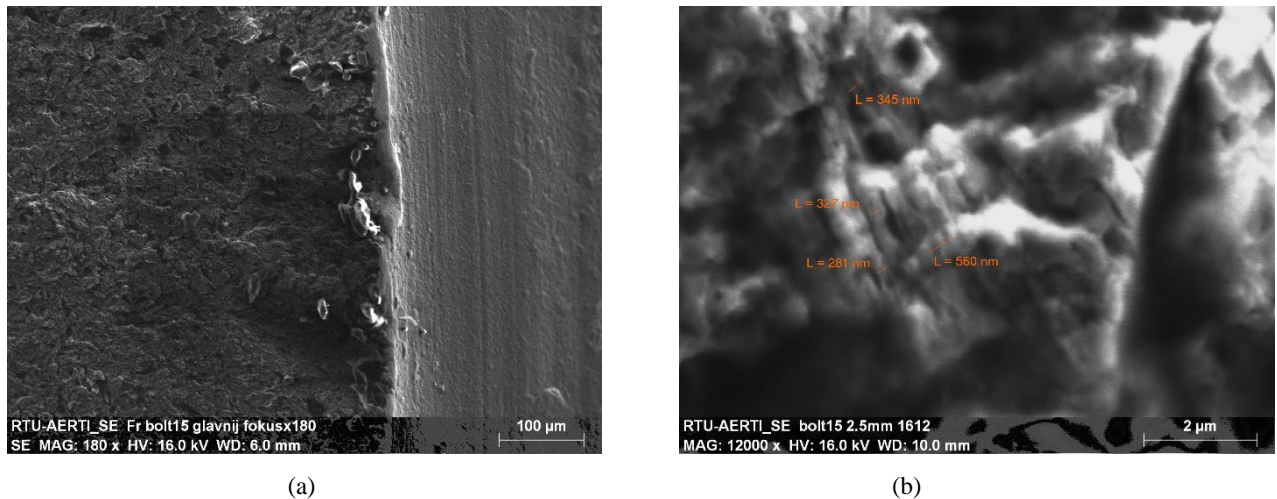
In the material of bolt No. 15, the average size of fatigue mesolines in the area on a radius of up to 3000  $\mu\text{m}$  from the nucleus (Fig. 10 a) is 180 nm (Fig. 10 b). The length of the given site corresponds to 16 666 load cycles.

Fig. 10. (a) Nucleus area and (b) fatigue mesolines  $h = 177$  nm to 186 nm (2.5 mm from the nucleus), bolt No. 15.

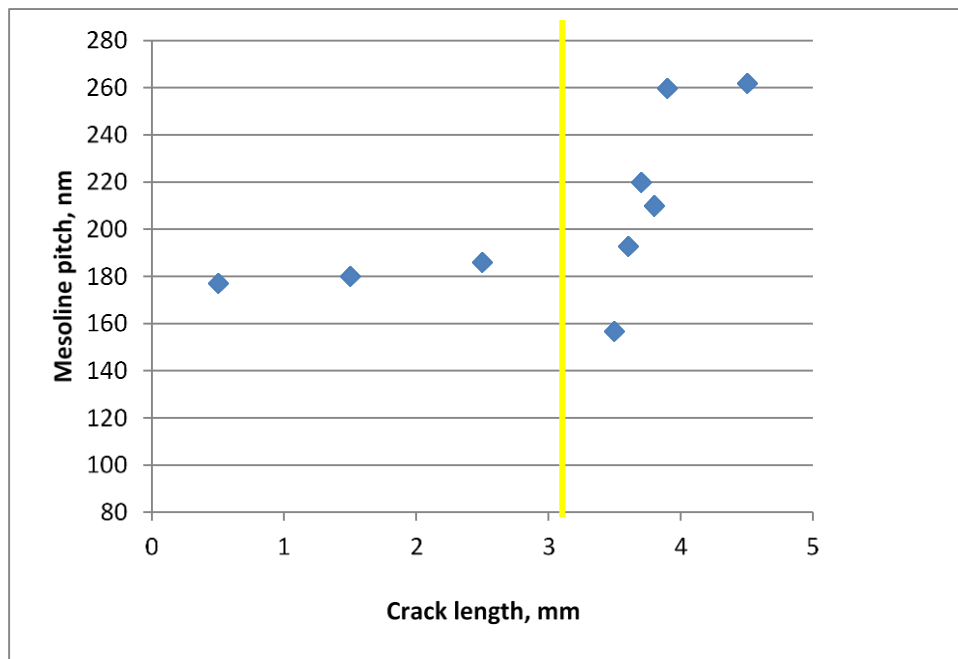
Then a characteristic area of crack arrest corresponding to approximately 4000 load cycles was observed on the fracture (Fig. 11). Apparently, crack propagation stopped due to the reduction of load on the bolt as a result of bolt retightening after the failure of bolt No. 14 (at the number of load cycles equal to 69 603 [3]).

Fig. 11. Dependence of fatigue mesoline pitch increment on the length of the fatigue crack with account of retightening of bolts in the joint between the tail boom and fuselage, bolt No. 15.

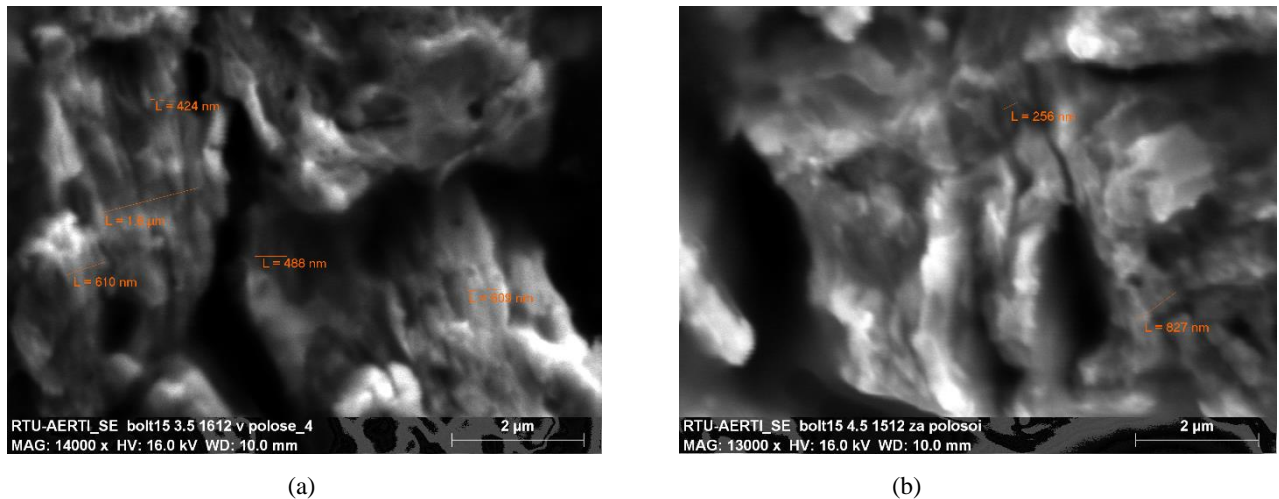
Then during 8998 cycles the destruction of the bolt was taking place. At the same time the crack growth rate on a radius of 3 mm to 3.2 mm from the nucleus was on average 150 nm; then on a site with a radius from 3.2 mm to 3.5 mm it was 230 nm (Fig. 12 a), which corresponds to a total of 2637 load cycles. After reaching a radius of 3.5 mm from the nucleus, an accelerated growth of the crack was being observed during 2000 to 2100 load cycles (Fig. 12 b).

Fig. 12. Fatigue mesolines, bolt No. 15. (a)  $h = 200$  nm to  $245$  nm ( $3.5$  mm from the nucleus). (b)  $h = 256$  nm to  $275$  nm ( $4.5$  mm from the nucleus).
