# Research on the Propagation of AE Signals in Helicopter Structural Components

**Abstract** – The paper contains results of experimental research carried out helicopter bench. In order to create an attenuation chart for AE signal amplitude in helicopter fuselage, a number of experiments were performed on the frame and stringers, inside the fuselage. Later helicopter test bench was used to develop defect localization methodology of helicopter structure fatigue damage technical diagnostics. Analysing helicopter structural defects for different helicopters types it is concluded that the joint elements of helicopter tail boom are still exposed to fatigue crack formation. AE method shows highly effective results predicting fracture of helicopter joint elements.

#### IV. ANALYSIS OF TEST RESULTS PRIOR TO THE FAILURE OF BOLT NO. 15

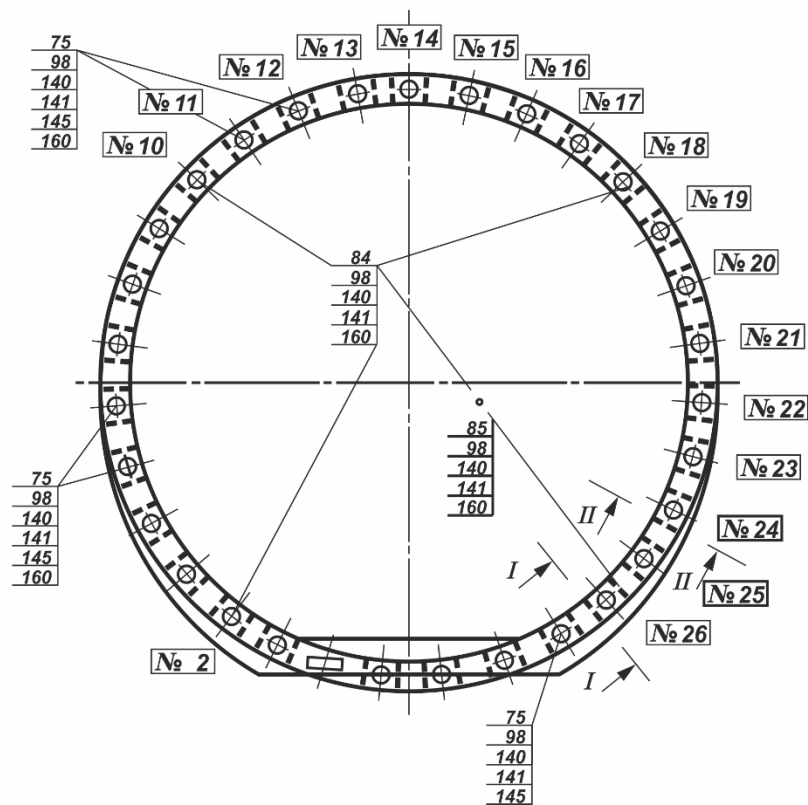
Fig. 5. Joint bolts of tail boom frame No. 1 and fuselage in flying direction.

In the process of inspection in 78 603 cycles, some loosening of attachment bolt No. 15 in the area of stringer No. 1 along the right side was found. The failure was detected on the basis of AE monitoring data [6] in 78 600 load cycles. To remove the bolt, the helicopter tail boom weight was relieved. The bolt appeared to be destroyed and came out without any effort.
